Salt tailings

Geotechnical characterization of a complex material

Jelle van der Zon
24 November 2023

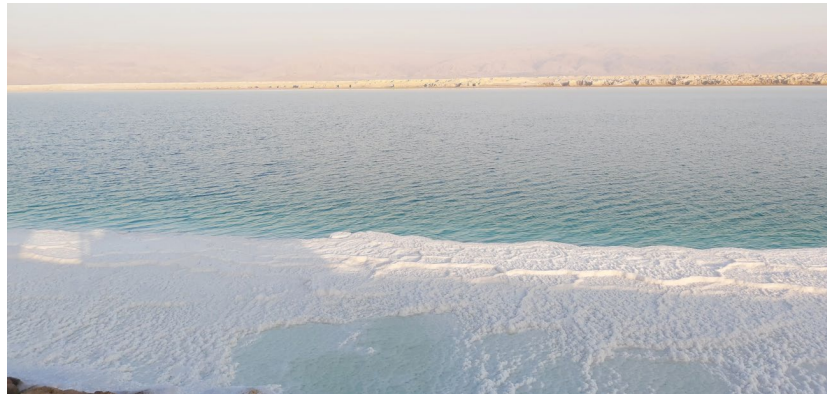
- Project (including large scale GI campaign) was performed for a client in potash industry in Jordan.
- Potash is a collection term for mined salt that contain potassium in water-soluble form. It is an important raw material for fertilizer production.
- The potash is not harvested in pure form, but as carnallite ($\text{KCl} \cdot \text{MgCl}_2 \cdot 6\text{H}_2\text{O}$) following evaporation and precipitation in salt ponds.

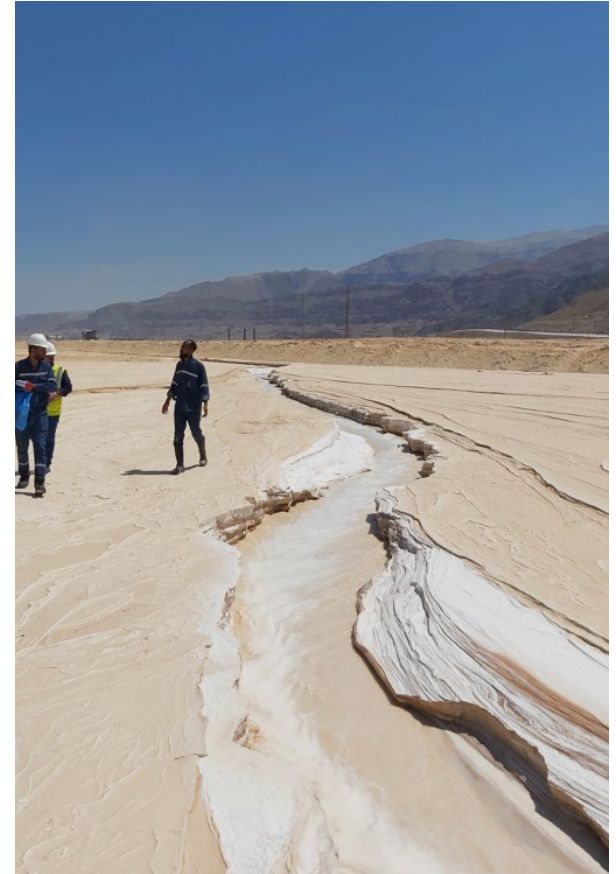
- In refineries, the potassium is separated from the other salts.
- This generates a waste stream rich in regular NaCl salt. These salt tailings are of little value and disposed of in tailings areas.
- At the client's location, these salt tailings are hydraulically transported to the tailings area.

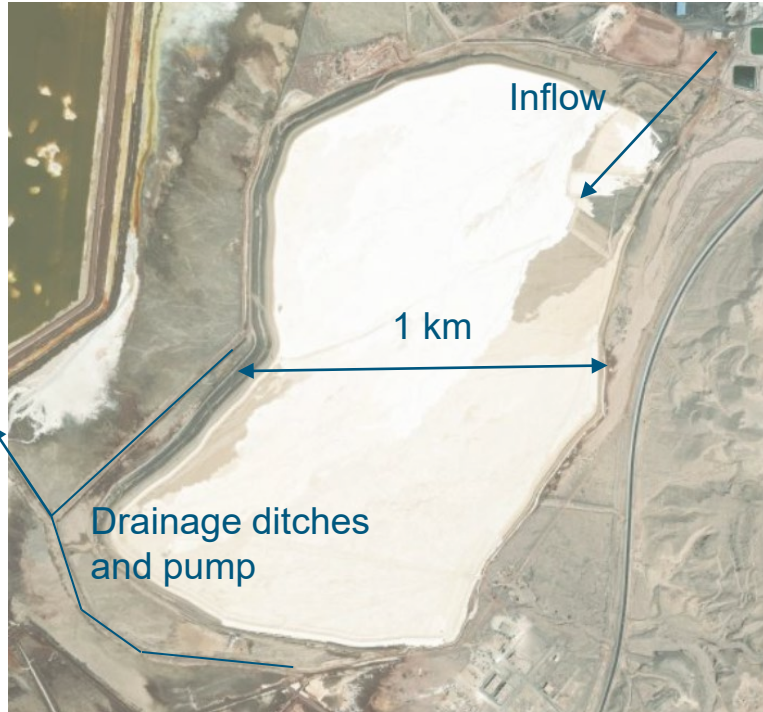
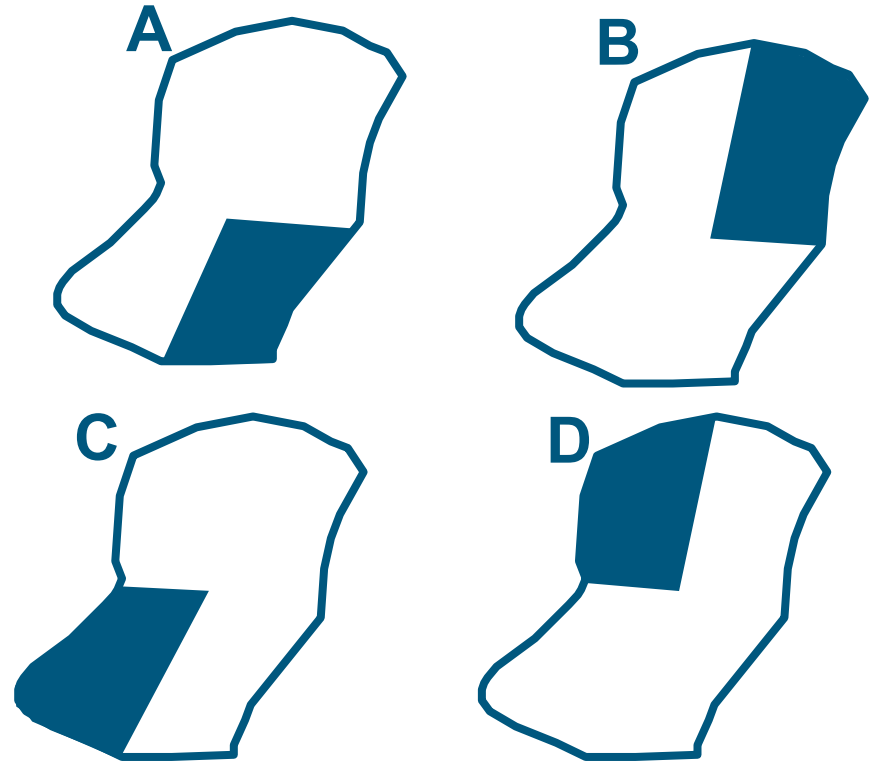
Process of disposal

Raise $\sim 0.5-1.0$ m/year.
Drying and wetting cycles

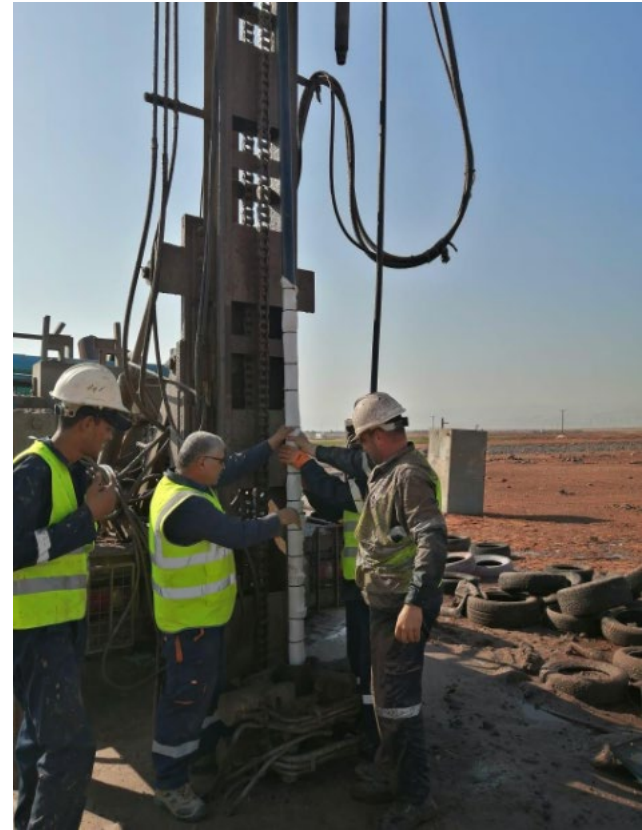
- As part of the 'zero-liquid discharge' policy of the client, a sealing of the tailings area had to be designed. The policy is aimed on reduction of spoiling still valuable materials and minimization of the environmental impact.
- A GI campaign was performed to better understand the carrying capacity and behaviour of the salt tailings.

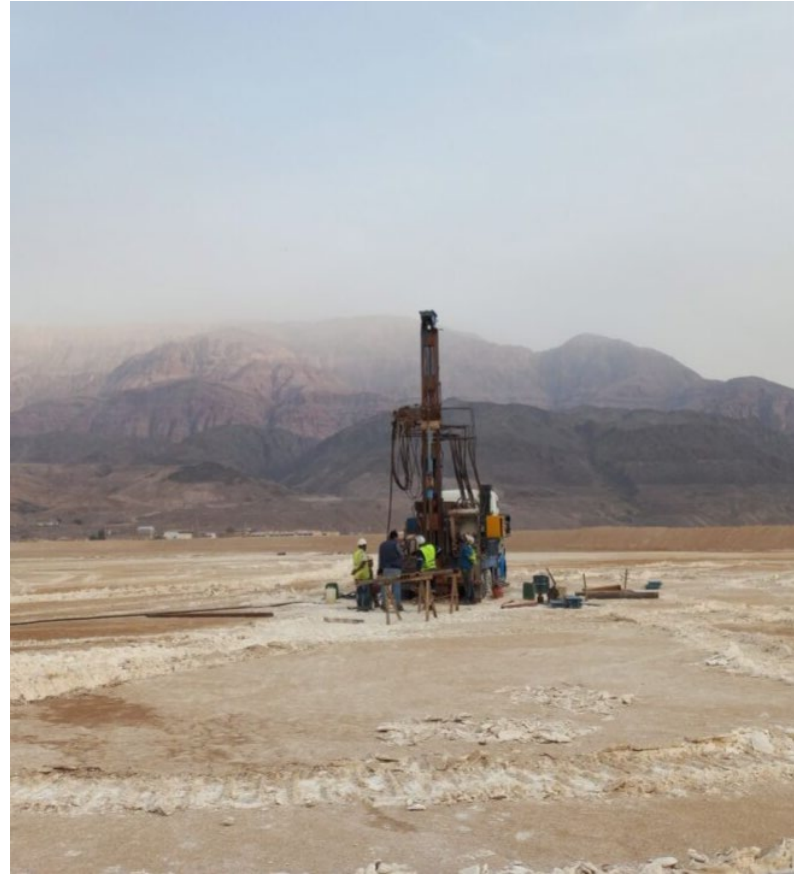
Overview GI (salt tailings)

- 4 boreholes
- 37 SPT tests
- 14 permeability tests

- 30 density tests
- 28 point load tests
- 2 UCS tests (30 were planned)

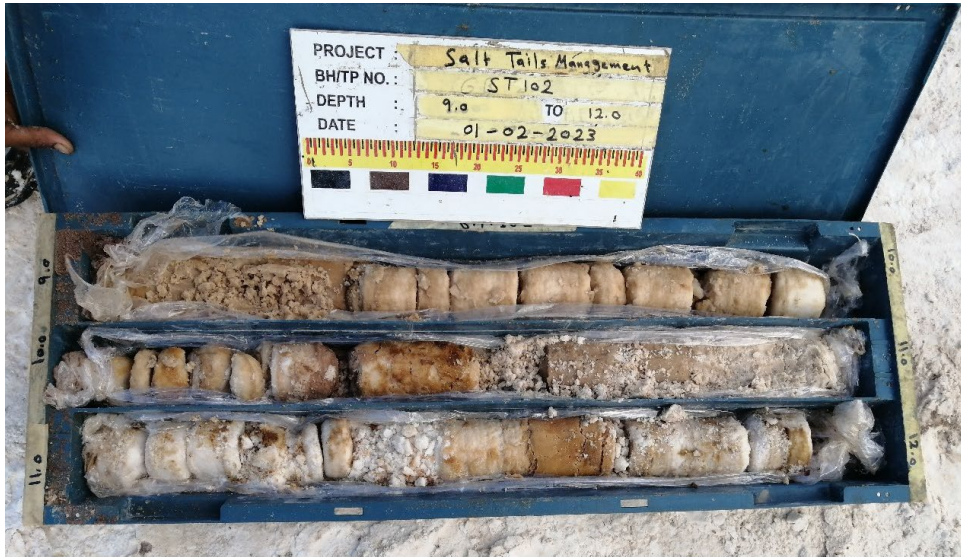
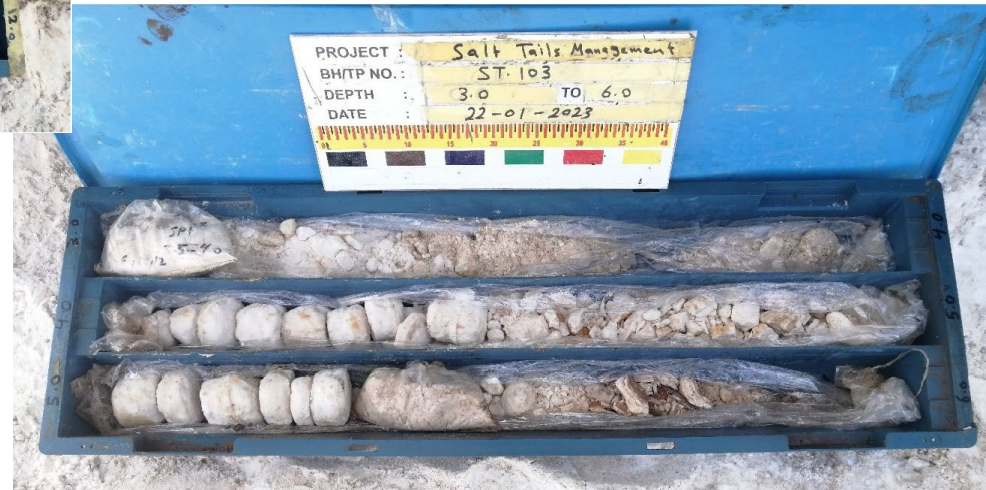
Results - Boreholes and in-situ testing

Mass strength of salt highly influenced by the presence of dust (brown salt).

Fragmented disks of salt, or even pulverised material. Samples were highly disturbed during drilling (even when using double coring)

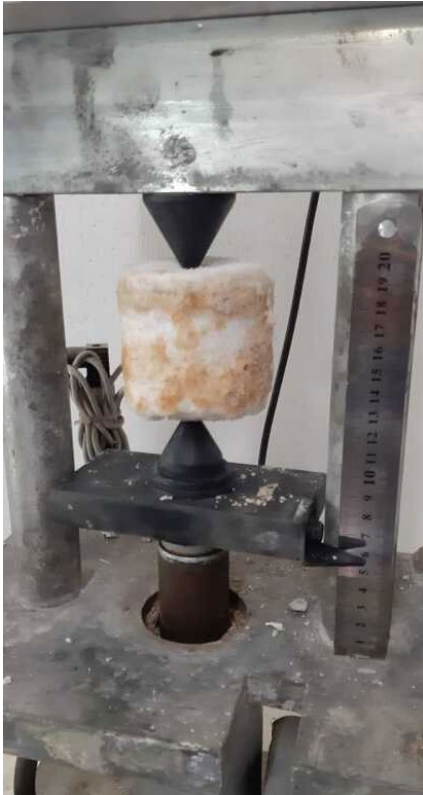
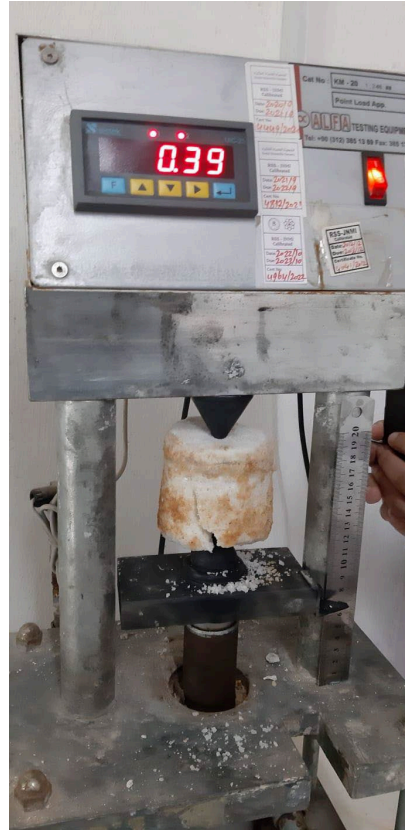
Results - Laboratory testing

- Only two UCS tests could be performed because samples were not of sufficient size.
- UCS tests done gave cohesive values of 450 to 700 kPa, but are not representative for the mass strength (only the best test samples survived drilling and coring).
- Other strength tests (e.g. Brazilian tensile test or bending tests) were not feasible as it needed cutting in the samples which was not desired (friable material).
- Testing programme was changed to point load testing (next best). Point load testing is an index method which provides with only an indirect measure of strength.

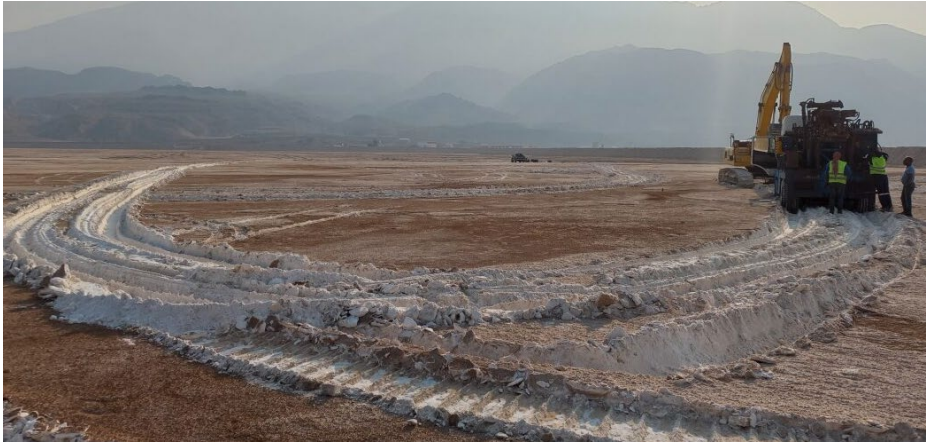
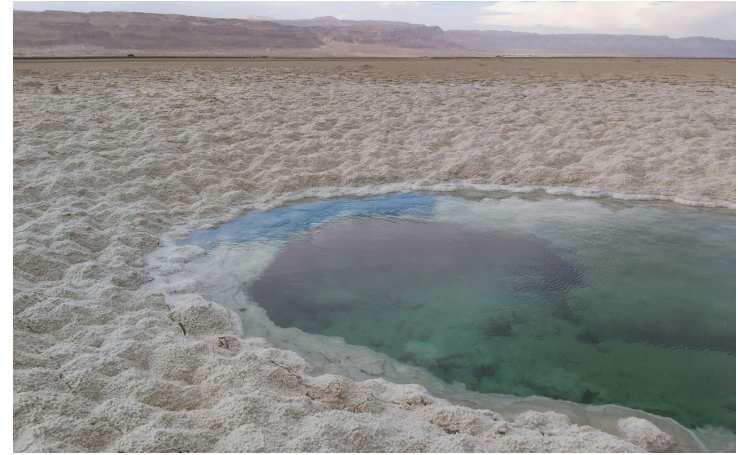
Behaviour of tailings – effect of depth

Salt tailings has little mass strength under no confining pressure (very low moisture contents (“dry”)).

Completely opposite to salt crusts without confining pressure formed under precipitation but now above groundwater level.

Mass strength increases quickly with depth.

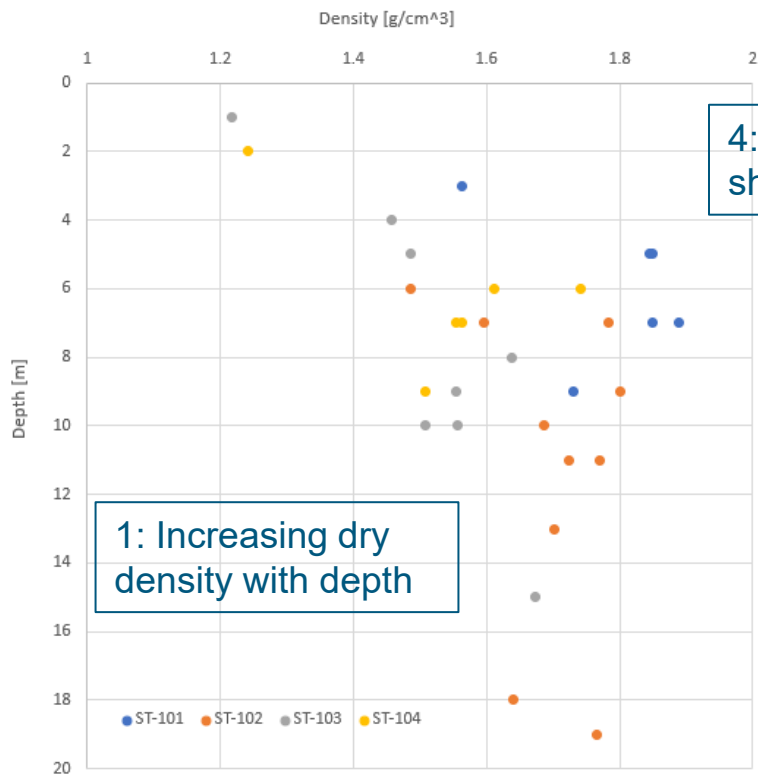
4: High variability at shallow depth

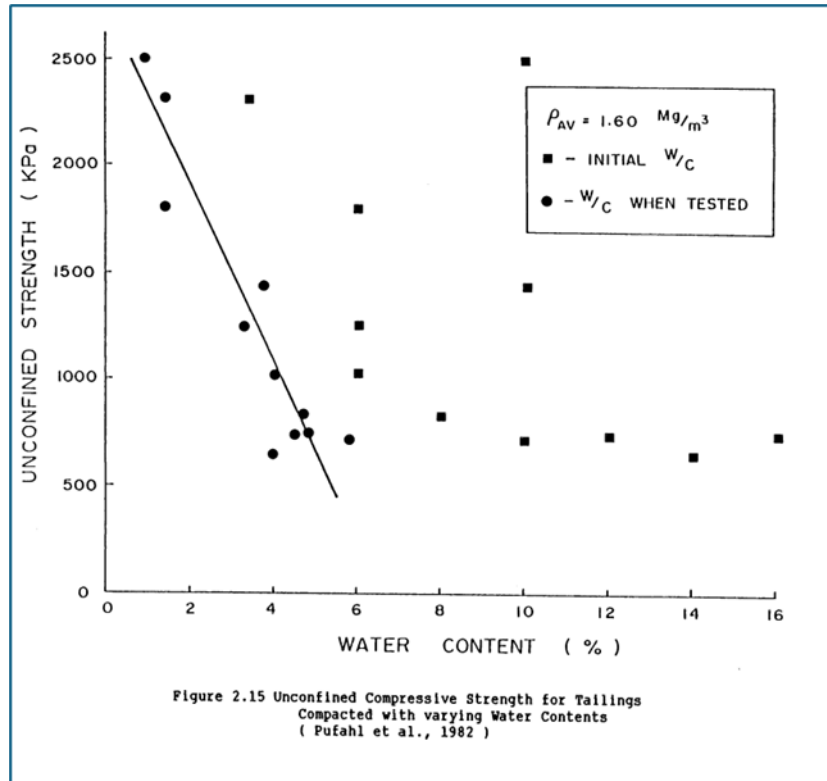
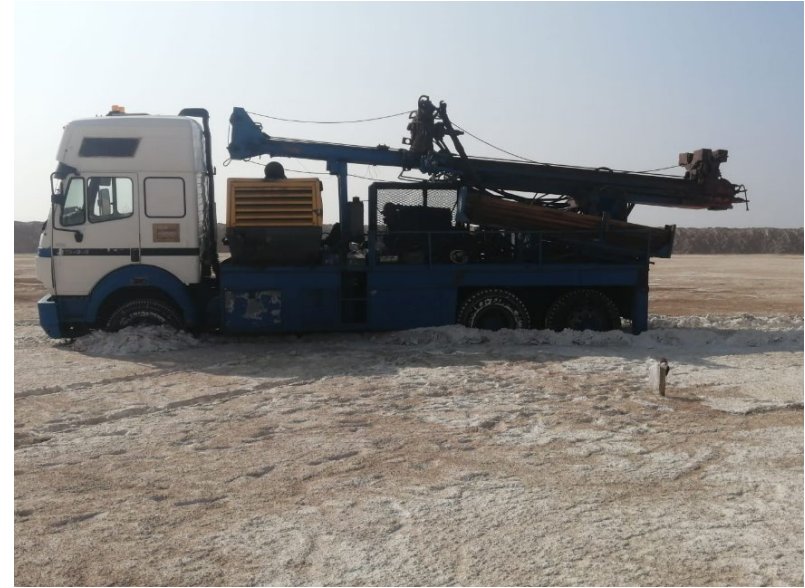
Behaviour of tailings – moisture content

Cohesive bond is broken by rewetting (even by saturated brine).
Wet salt tailings are very weak.
