Annual symposium on the theme  
“Post-mining risk management in the Netherlands”:

## **Dealing with Post-Mining-Hazards**

**From theoretical approach to practical remediation**

Ingenieurbüro Heitfeld - Schetelig GmbH

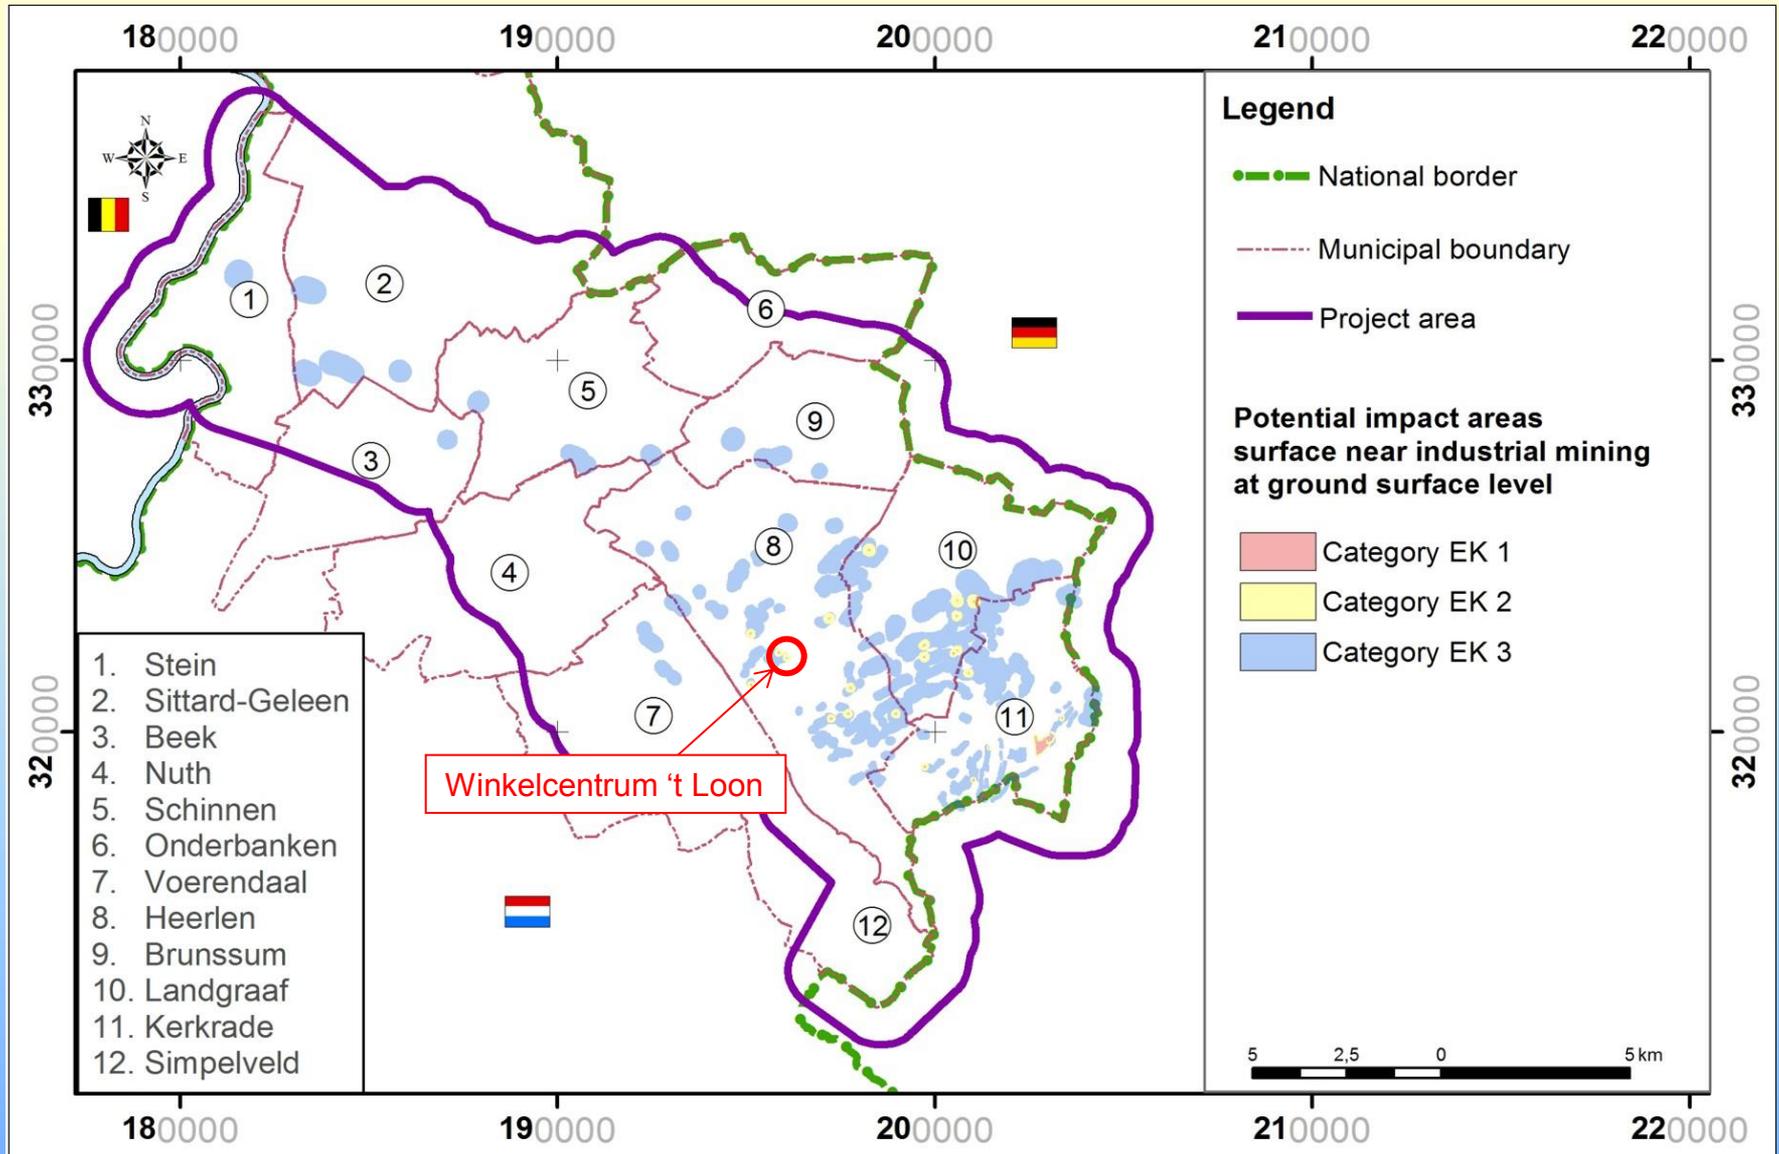
## Map of the potential impact areas in project areas 2/3

# Voids due to industrial near-surface mining

- **Historical mining in the area of Kerkrade mostly of impact category EK 2 („yellow“) and EK 3 („blue“)**
- **Industrial mining mostly of impact category EK 3 („blue“)**
- **26 patches of impact category EK 1 („red“) and EK 2 („yellow“)**
- **Pre-active measures on existing situation are disproportional**
- **Awareness-raising**
- **Management of existing risks and avoid the creation of new risks**
- **Strict regulations on new construction buildings**

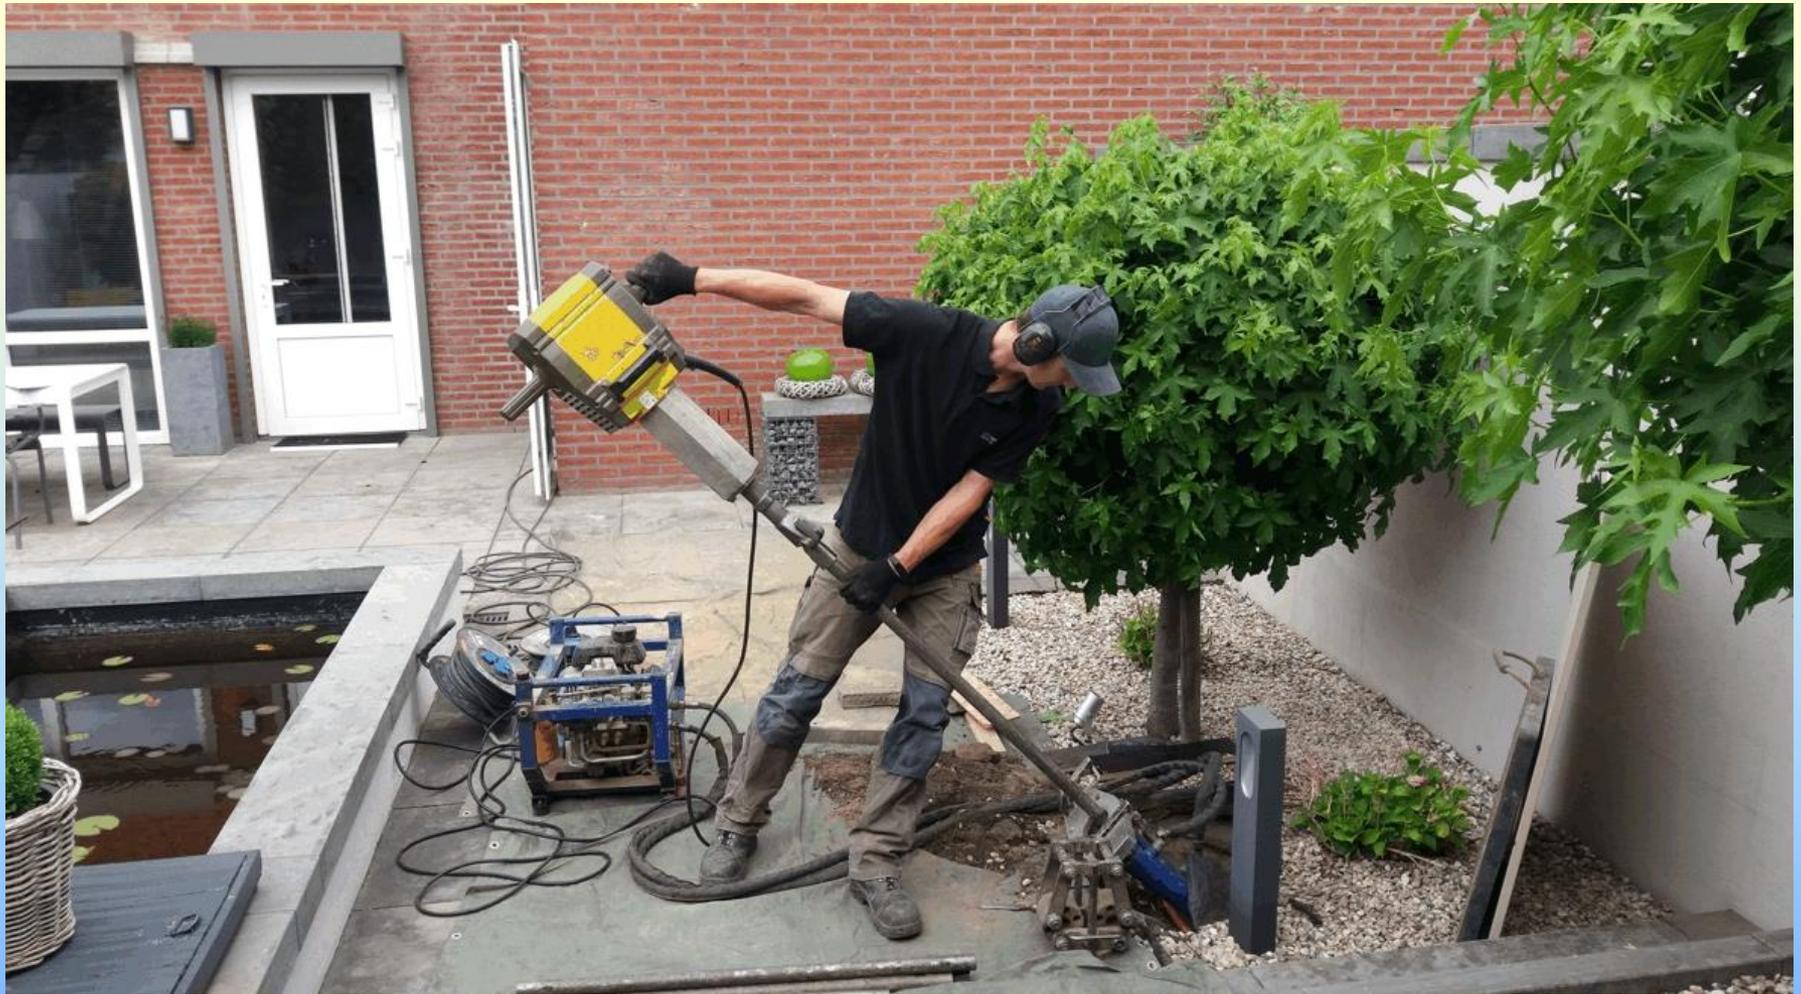
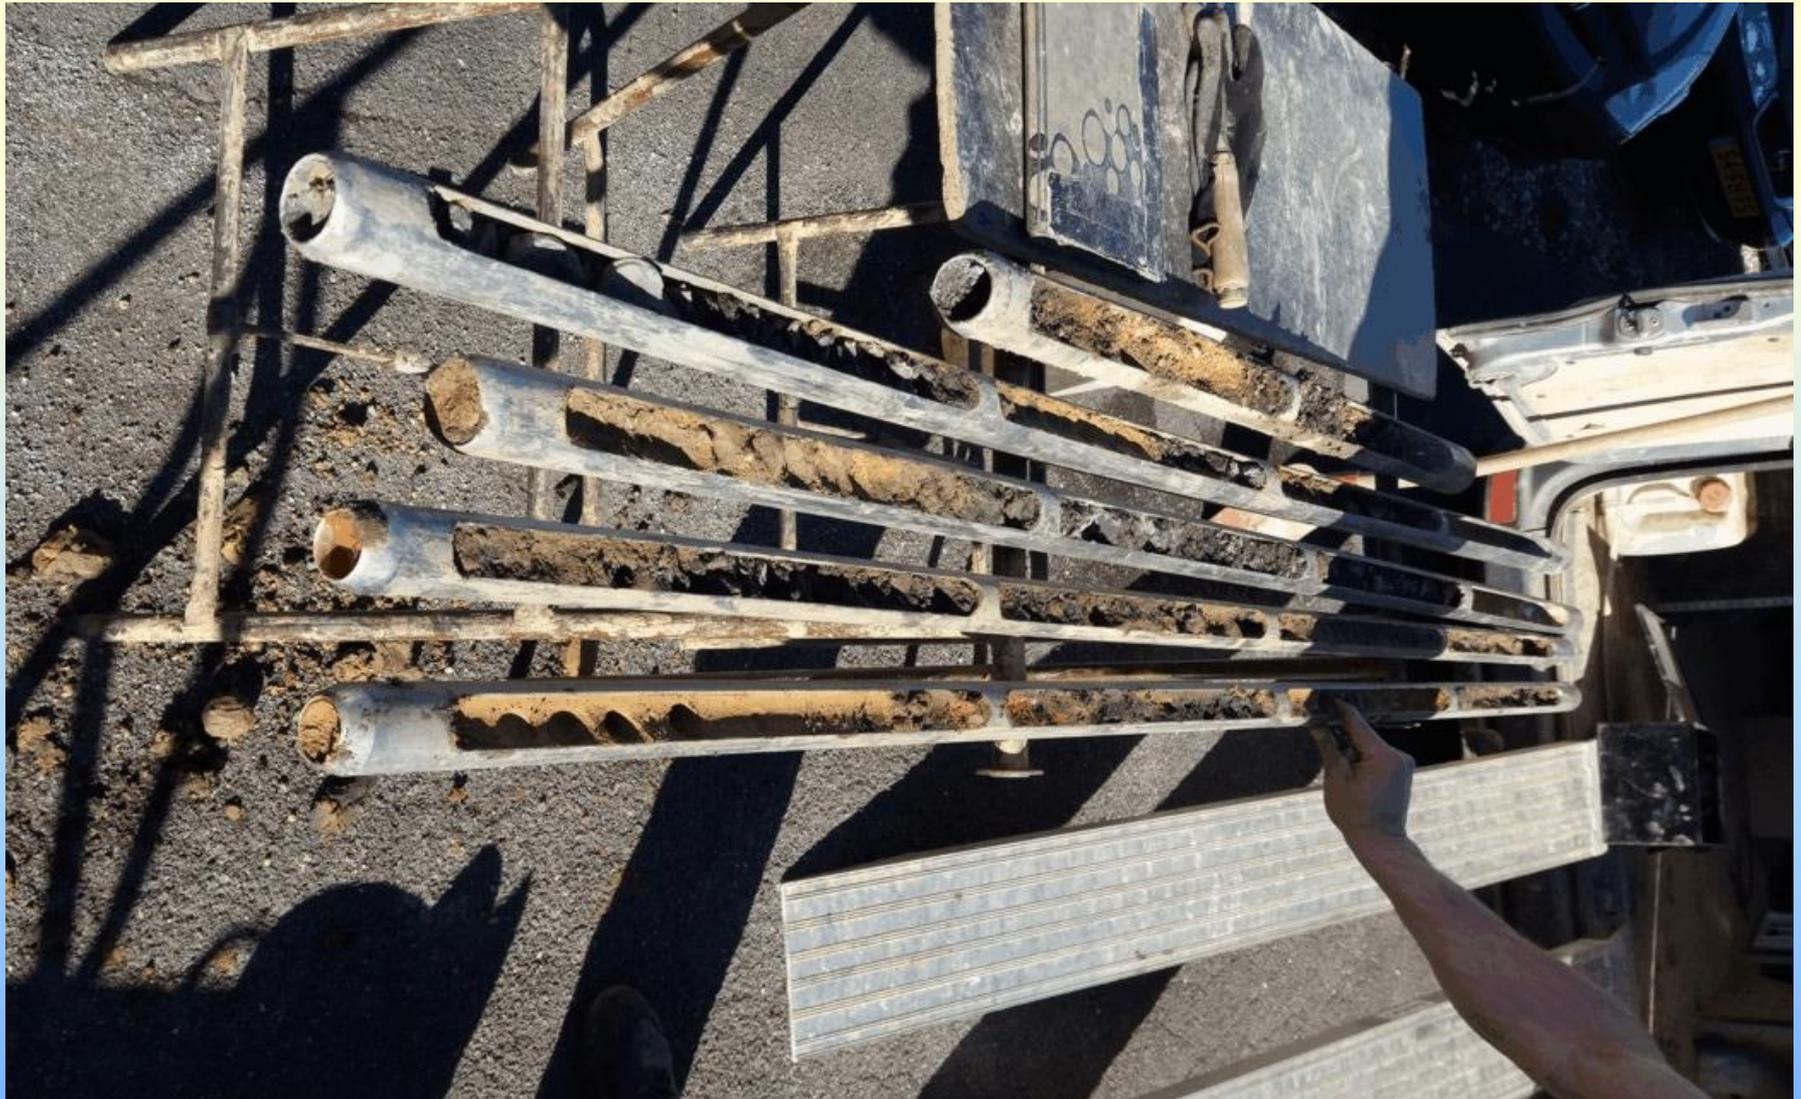
## Step 2

- Preliminary investigations by small hammer drivings
- Vertical small hammer drivings in a grid pattern of i.e. 3 x 3 m
- Meanwhile first test of inclined small hammer drivings

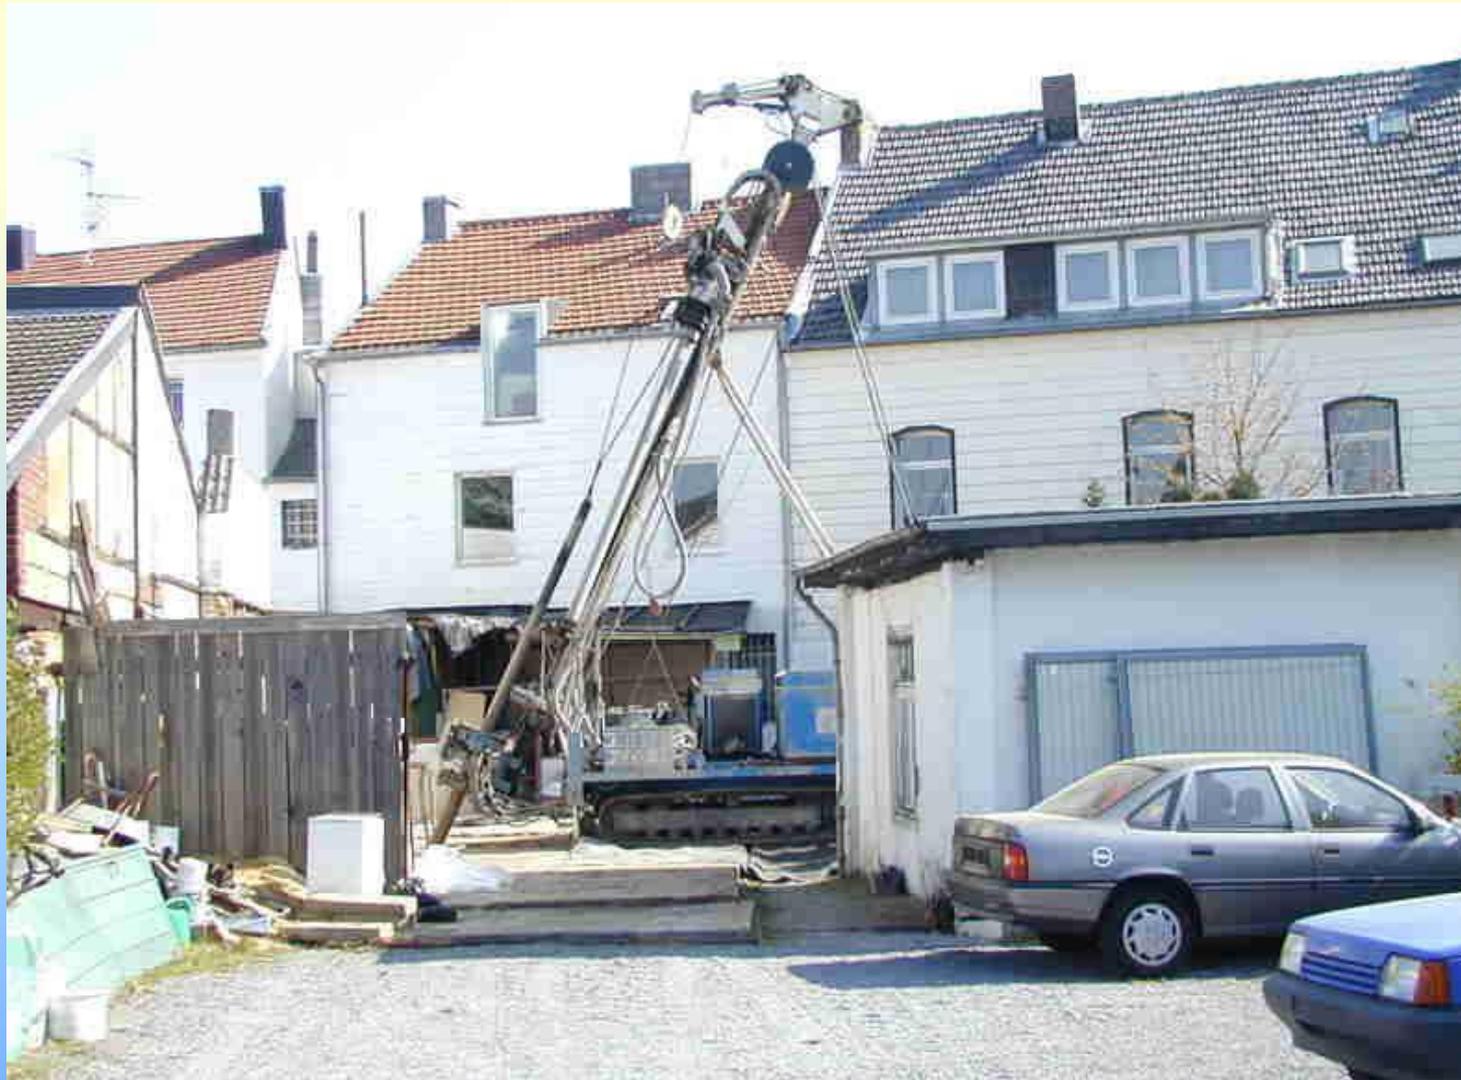
## Step 3

- **Investigation of larger depths by inclined core drillings**

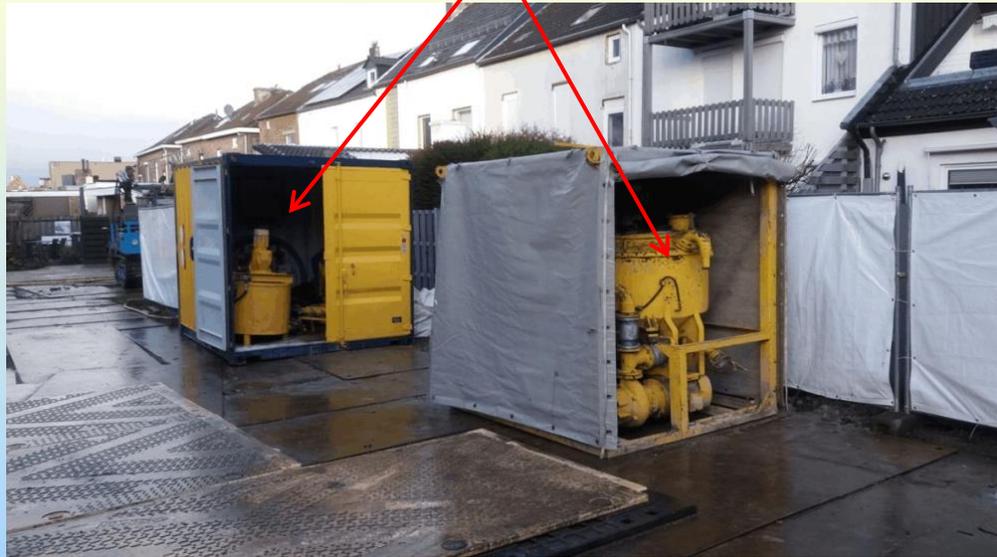
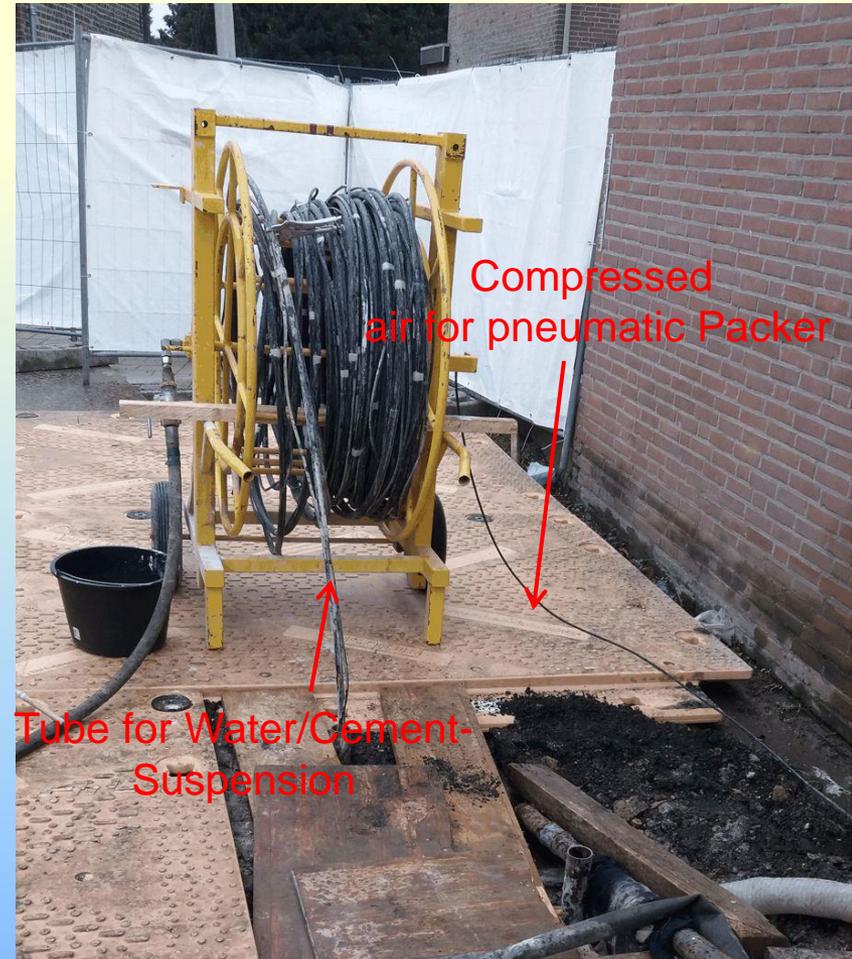
Mixer and Injection pumps
